CENTRAL VALLEY REGIONAL WATER QUALITY CONTROL BOARD

INSPECTION REPORT

LOCATION & COUNTY: Henry Tosta Dairy
20662 San Jose Road, Tracy
San Joaquin County

INSPECTION DATE: 5 September 2012

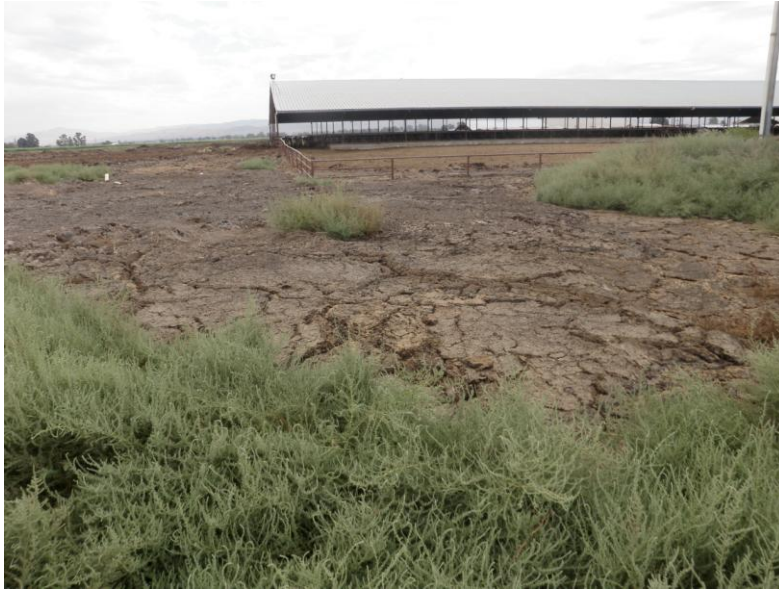
At the time of our inspection a medium sized loader was removing manure from the 3-4 acre area of native soil and stacking it immediately west of the lagoon complex. Mr. Tosta stated he is currently trying to rent equipment that will remove the liquid fraction from this area. Significant / massive amounts of solid manure, slurry manure, and liquid wastewater still remain in the 3-4 acre area of native soil. See Photos 1-4.

Photo 1: Looking south at the western end of the area of native soil that contains massive amounts of solid and slurry manure. No manure has been removed from this area.

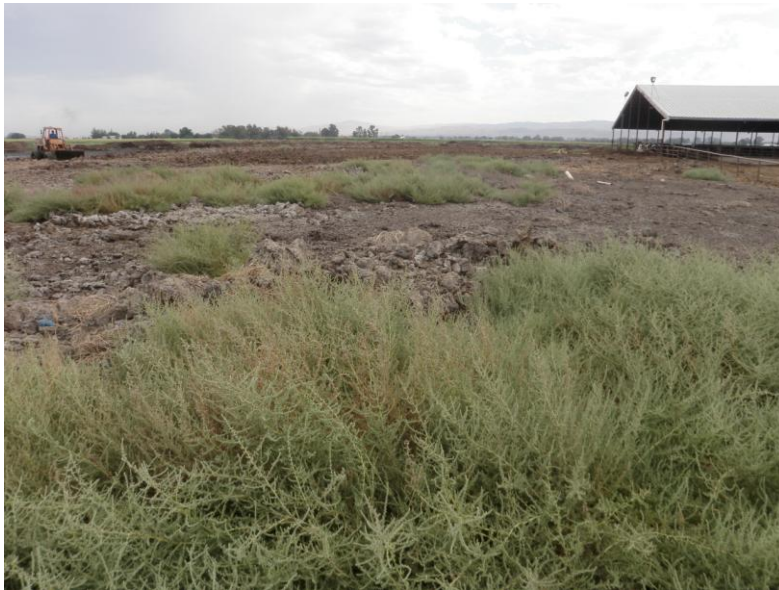
Photo 2: Looking south at the central portion of the area of native soil that contains massive amounts of solid and slurry manure. No manure has been removed from this area.

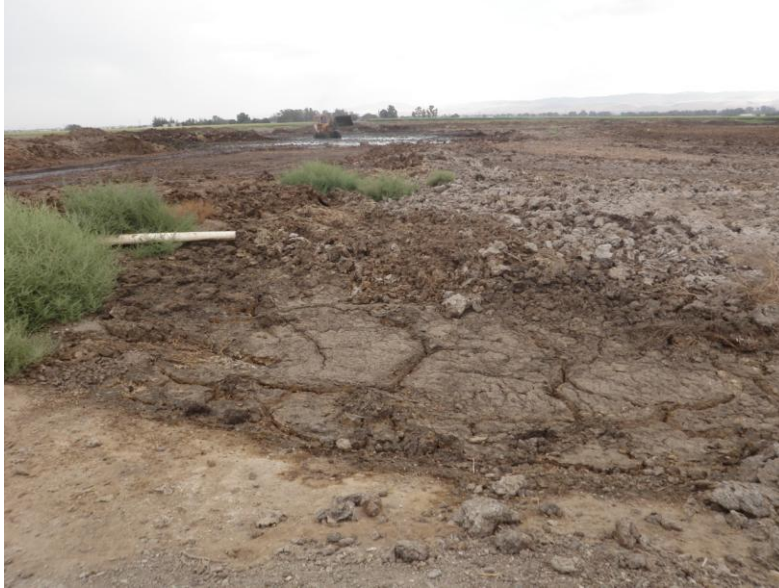
Photo 3: Looking south at the central portion of the area of native soil that contains massive amounts of solid and slurry manure. Although the tractor is pushing manure around, no manure has been removed from this area.

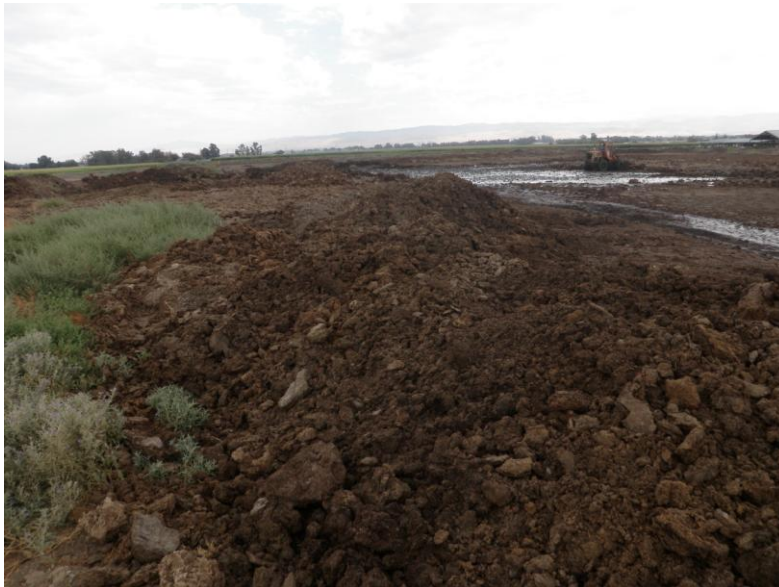
Photo 4: Looking south at the area of native soil from the western end of Wastewater Lagoon #4. The tractor is removing the manure from the western end of the 3-4 acre area of native soil and stacking it in loosely defined windrows at the eastern end of the 3-4 acre area of native soil, immediately west of the lagoon complex. At the time of the inspection no manure had been removed from this area.

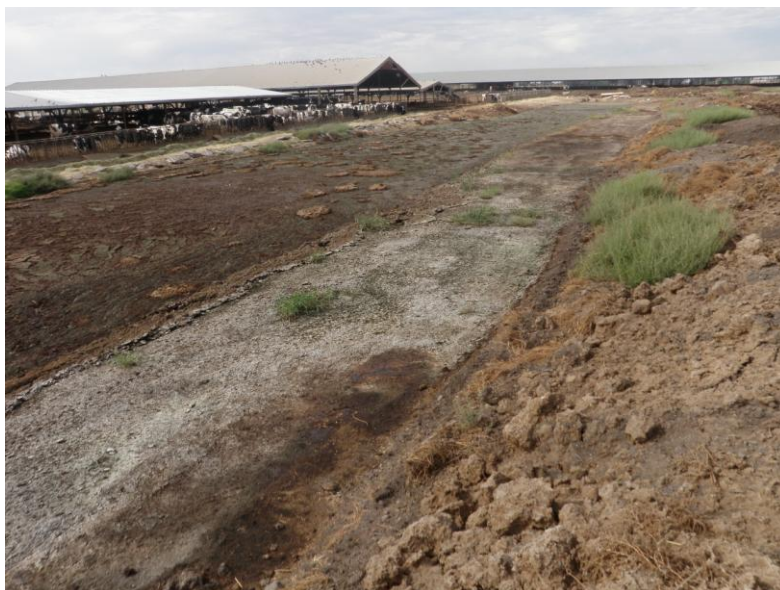
Photo 6: Looking north at Settling Basin #1. At the time of our inspection the basin had zero (0) freeboard and contained a significant amount of solid manure.

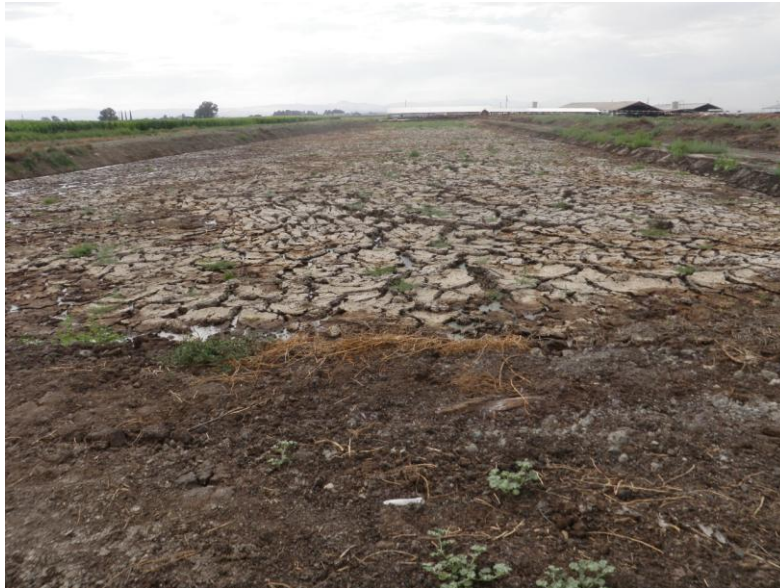
Settling Basin #2 contains significant amounts of solid and liquid manure. See Photos 7-8.

Photo 7: Looking west at Settling Basin #2. At the time of our inspection the basin contained significant amounts of solid manure.

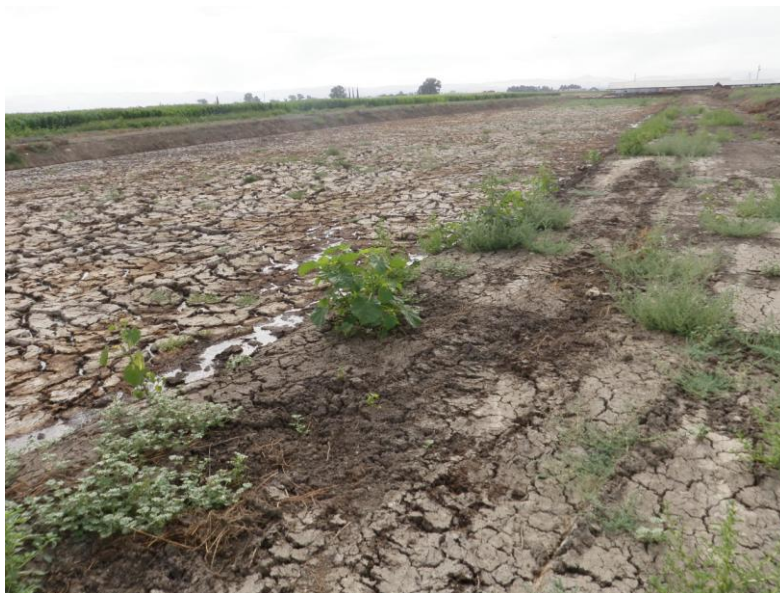
Photo 8: Looking south at Settling Basin #2. At the time of our inspection the basin contained significant amounts of solid manure.

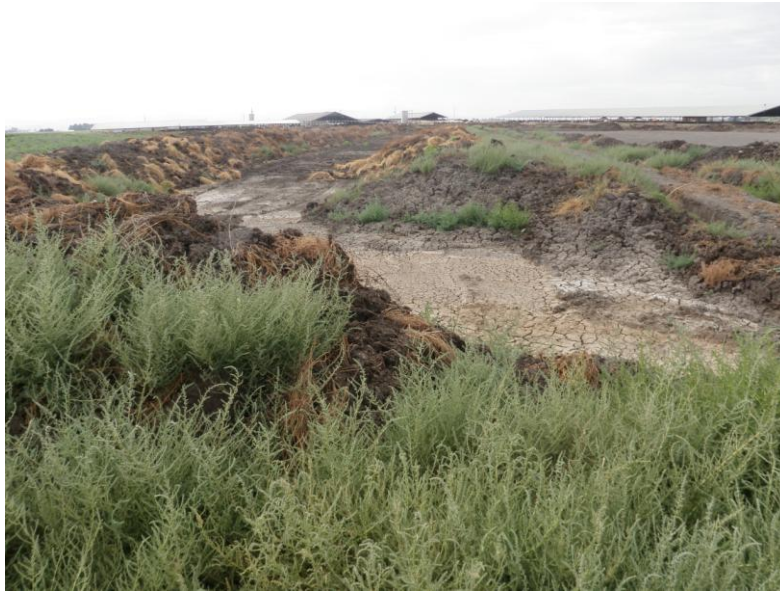
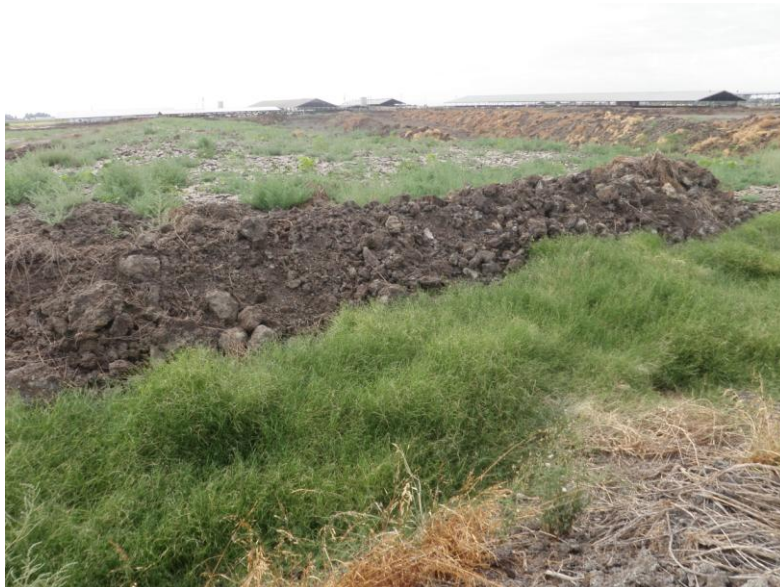
Wastewater Storage Lagoon #1 contains windrowed manure, solid manure, and slurry manure. Although the lagoon embankments are partially visible, it's hard to determine the actual footprint / dimensions of the lagoon. See Photos 9-10.

Photo 9: Wastewater Lagoon #1

Photo 10: Wastewater Lagoon #1

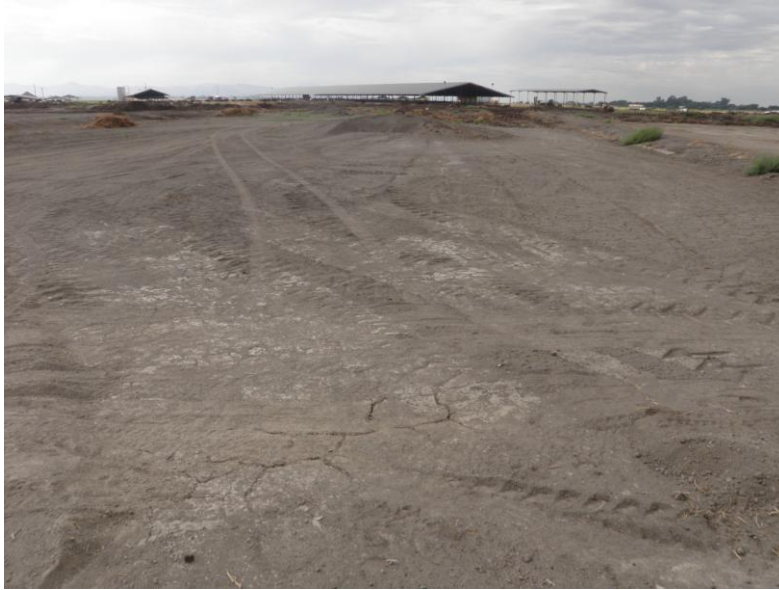
Photo 11: Wastewater Storage Lagoon #2.

The solid manure inside Wastewater Storage Lagoon #2 has been scraped up and piled inside the lagoon. See Photo 11.

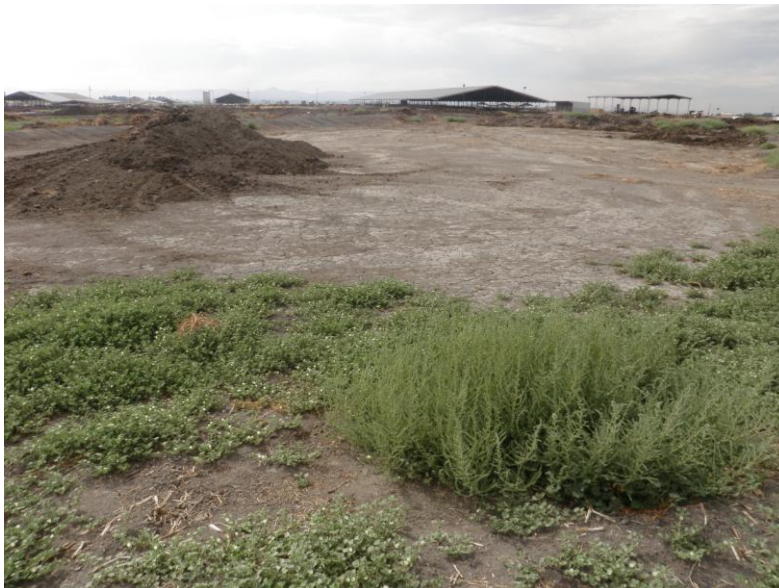
Photo 12: Wastewater Storage Lagoon #3

The solid manure inside Wastewater Storage Lagoon #3 has been scraped up and piled inside the lagoon. See Photo 12.

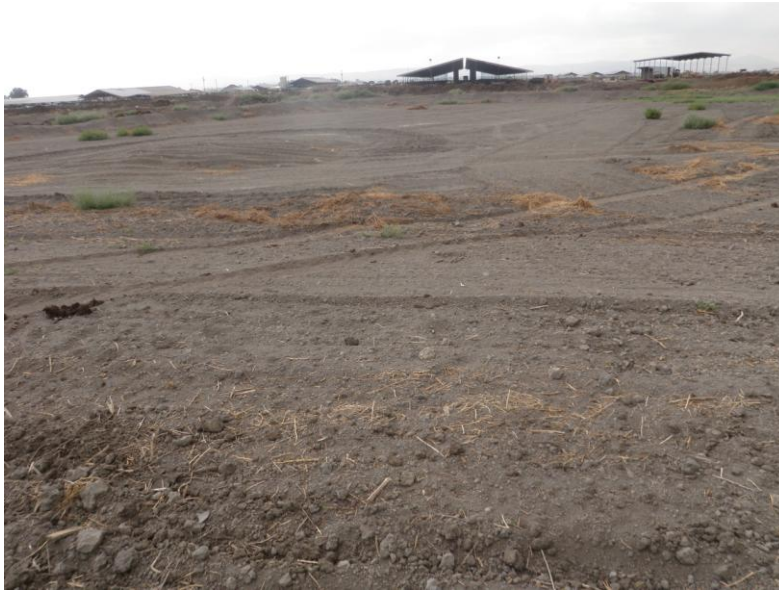
Photo 13: Wastewater Storage Lagoon #4

The solid manure inside Wastewater Storage Lagoon #4 has been scraped up and piled inside the lagoon. See Photo 13.

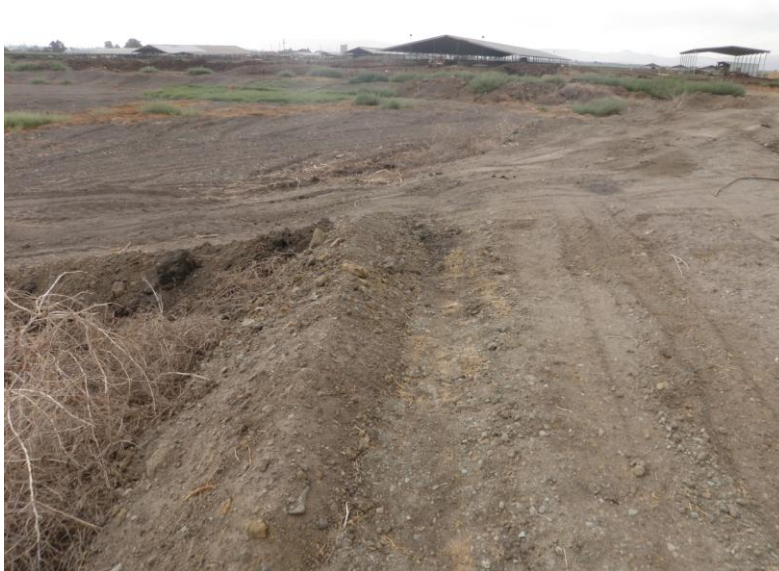
The solid manure inside Wastewater Storage Lagoon #5 has been scraped up and piled inside the lagoon. See Photo 13. The lagoon embankments appear to have been destroyed in the clean-up process; the eastern lagoon embankment has been removed. It's hard for staff to determine the lagoon footprint/dimensions. See Photos 14-15.

Photo 14: Wastewater Storage Lagoon #5. Looking west at the eastern and northern embankments.

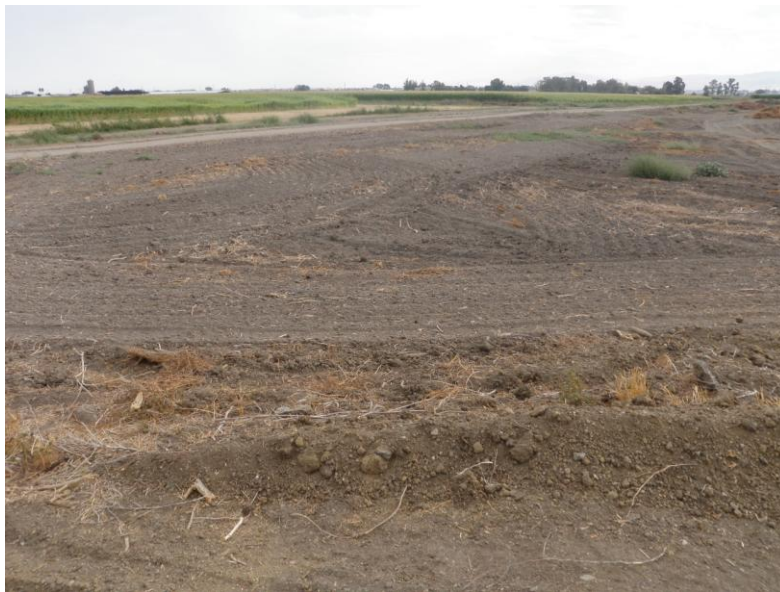
Photo 15: Wastewater Storage Lagoon #5. Looking southeast at the eastern embankment.
